MK2 S5E BiCS5 512Gb iTLC -2/4/8D Micro Package SDSM PQ Report

MPNs:
SDSMGKLK2-128G
SDMMGKLK4-256G
SDSMGKLK8-512G

WDC Packaging R2
6/8/2022

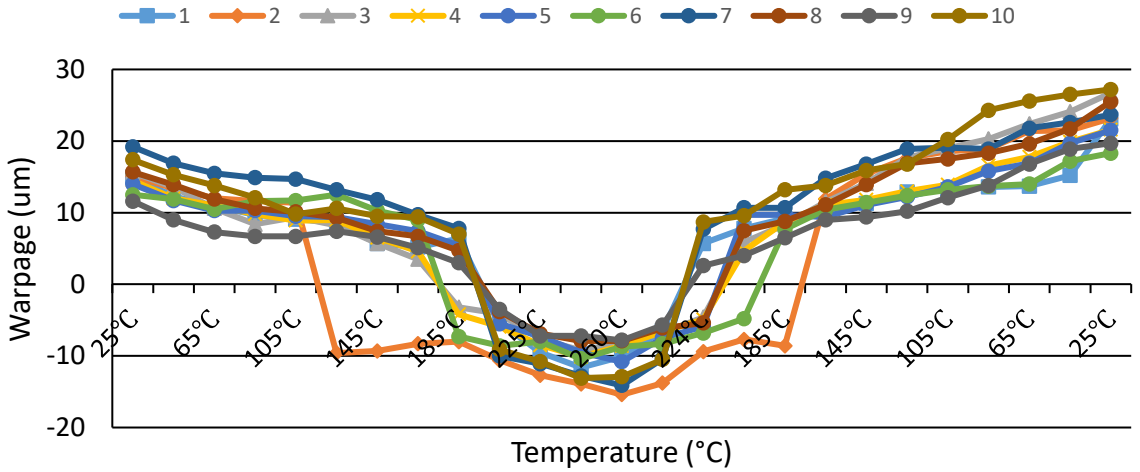
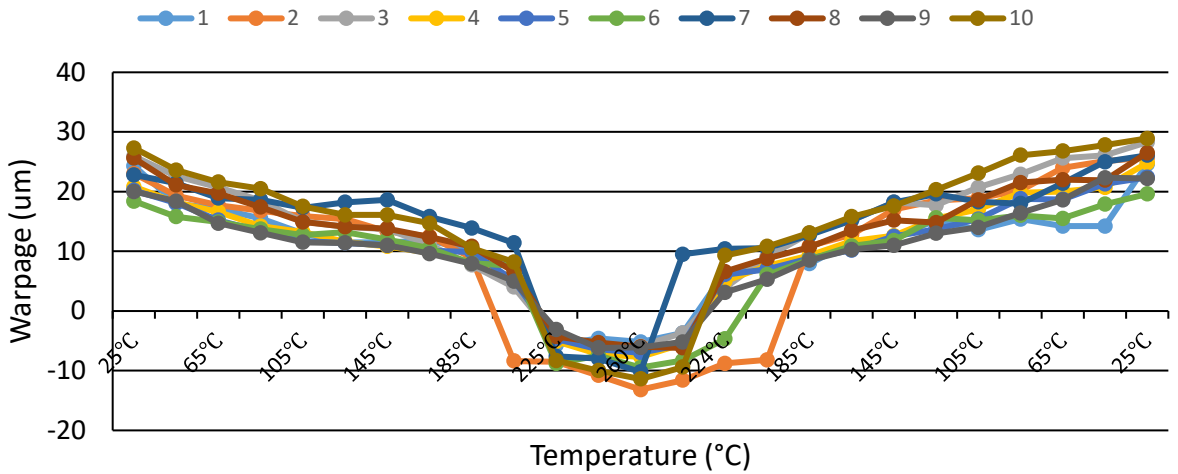
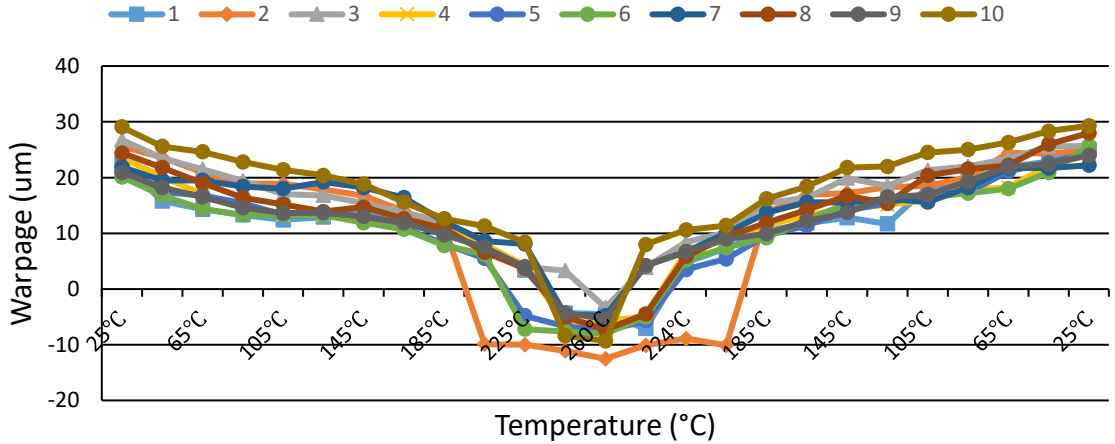
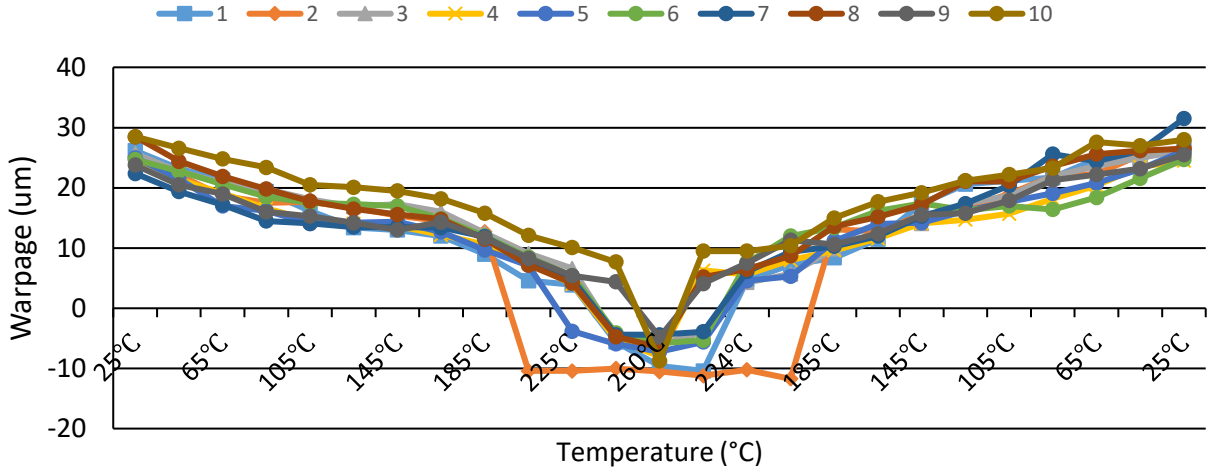
Shadow Moiré (2D)

Dry condition samples - meets Apple spec for all temperature range specified

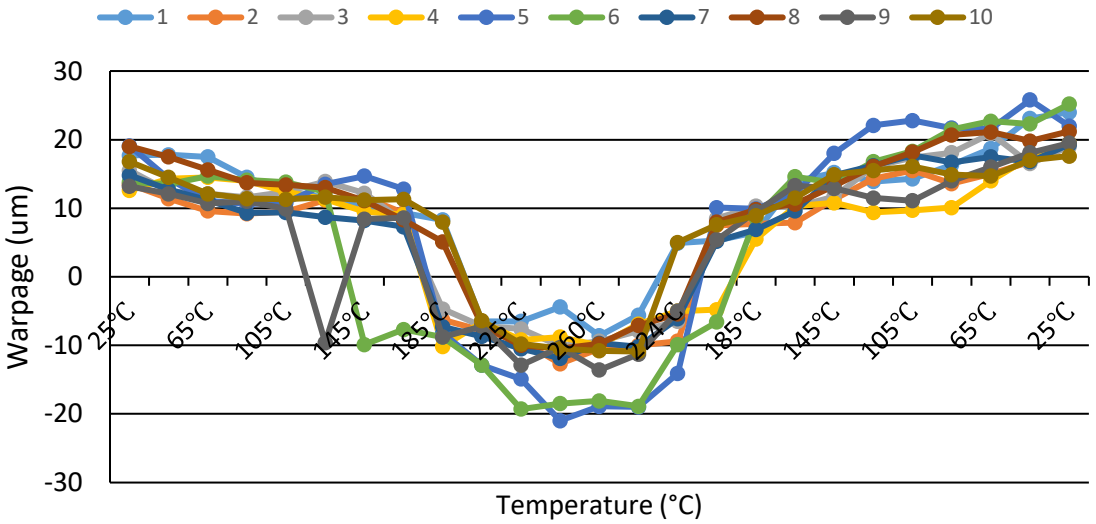
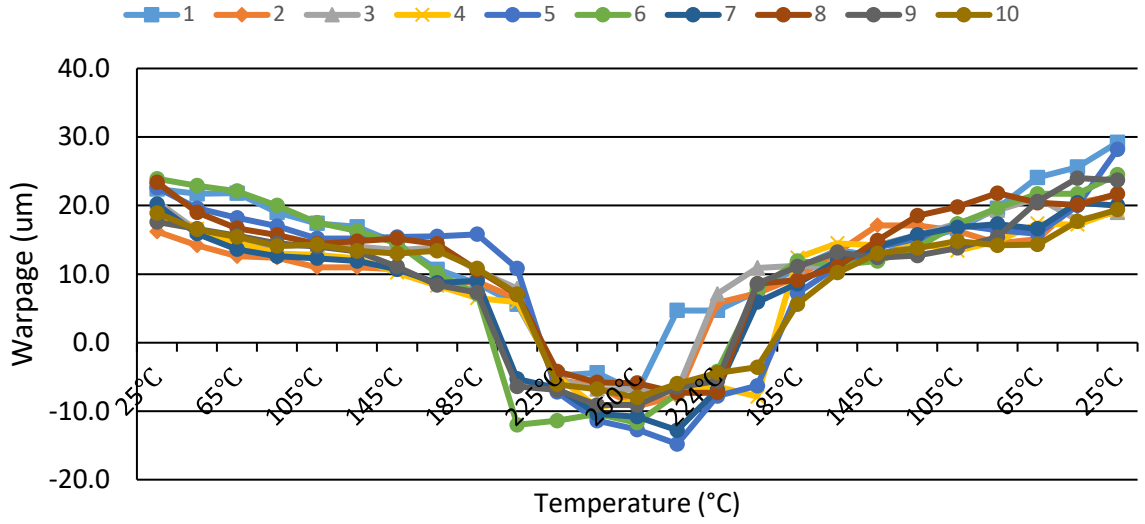
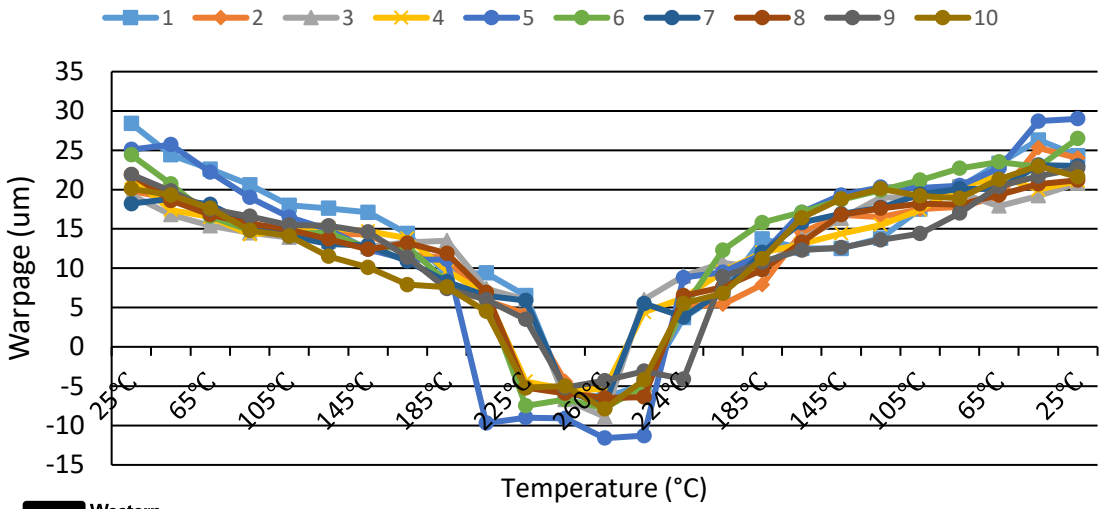
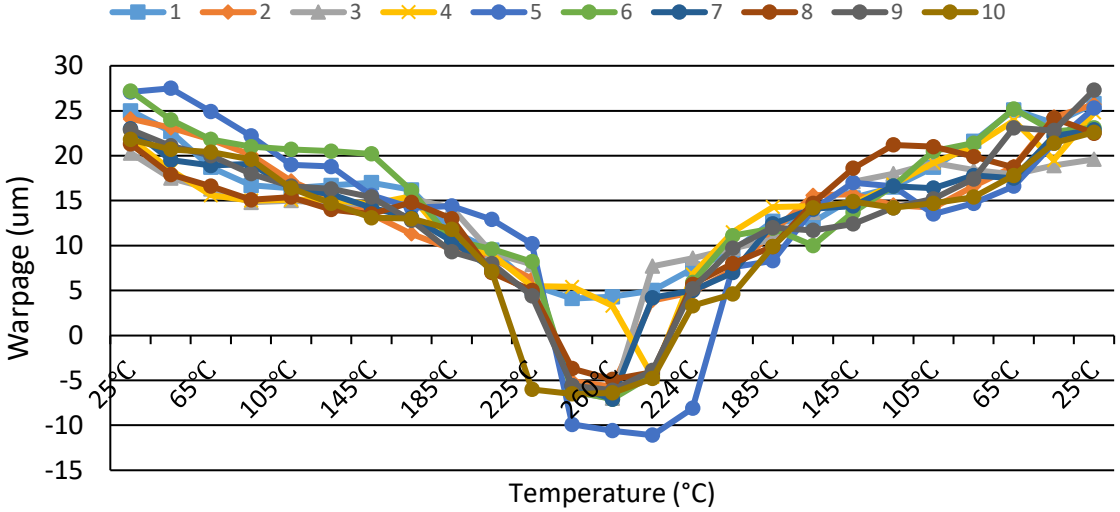
Shadow Moiré (2D)

Wet condition samples - meets Apple spec for all temperature range specified

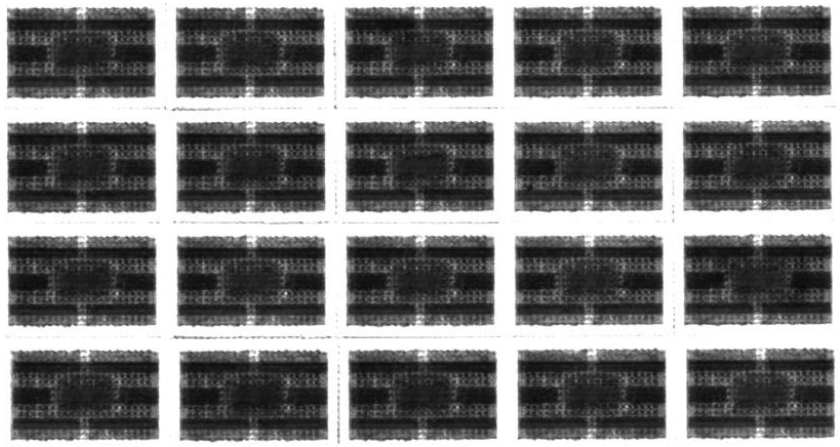
Contact Resistance and Delam check (2D)

- Data taken from 60 units from 3 PQ lots (20 units/lot)
- CSAM image post MSL3A shows no failures.

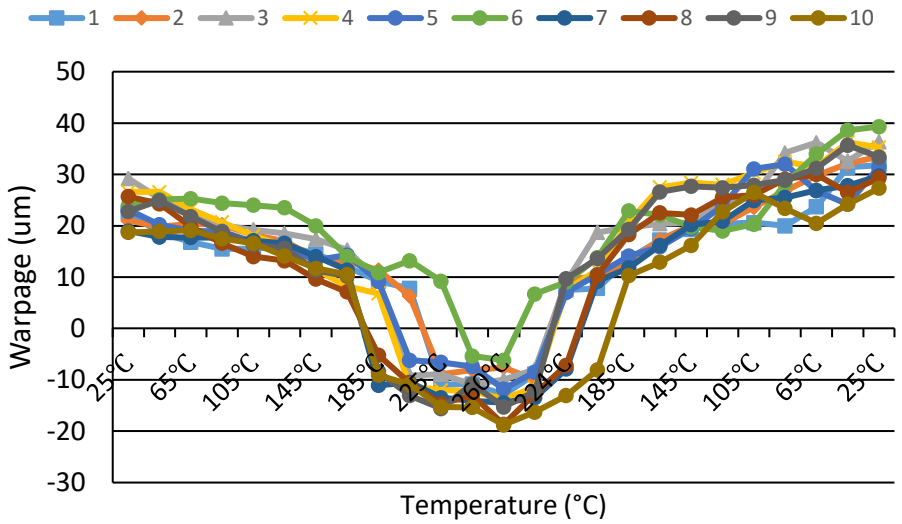
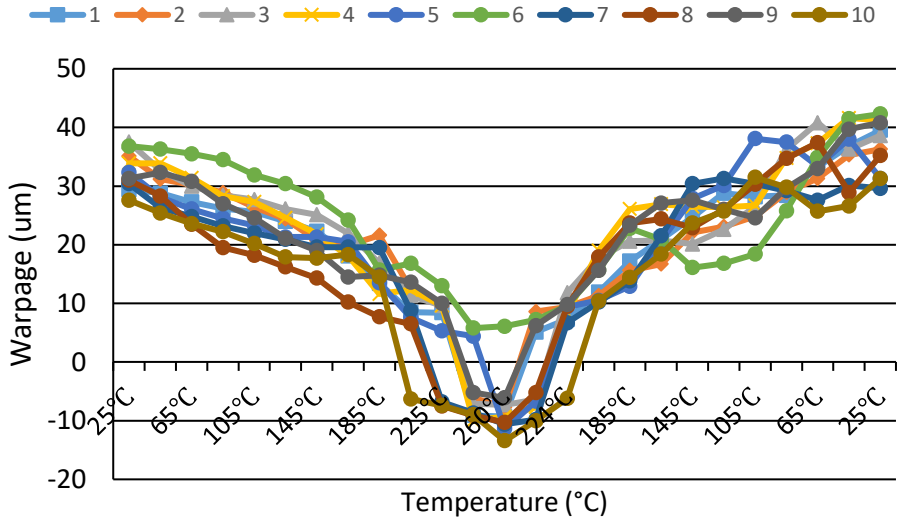
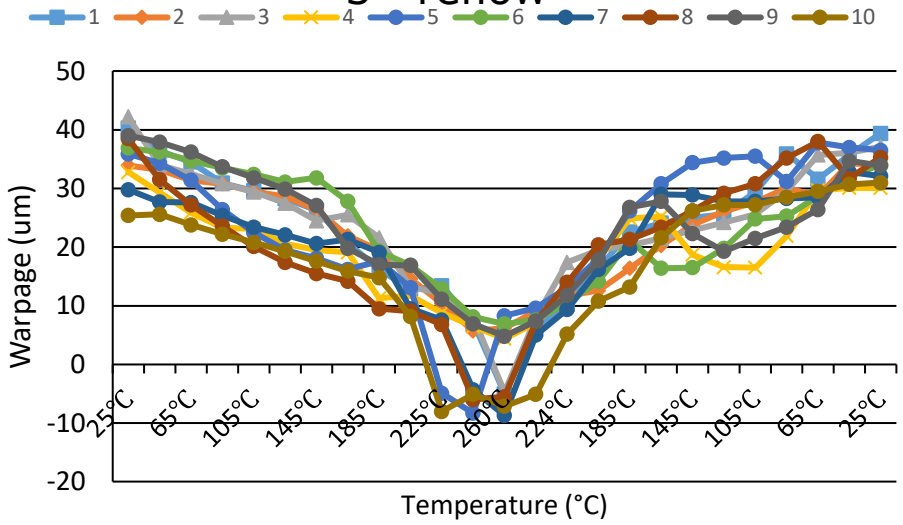
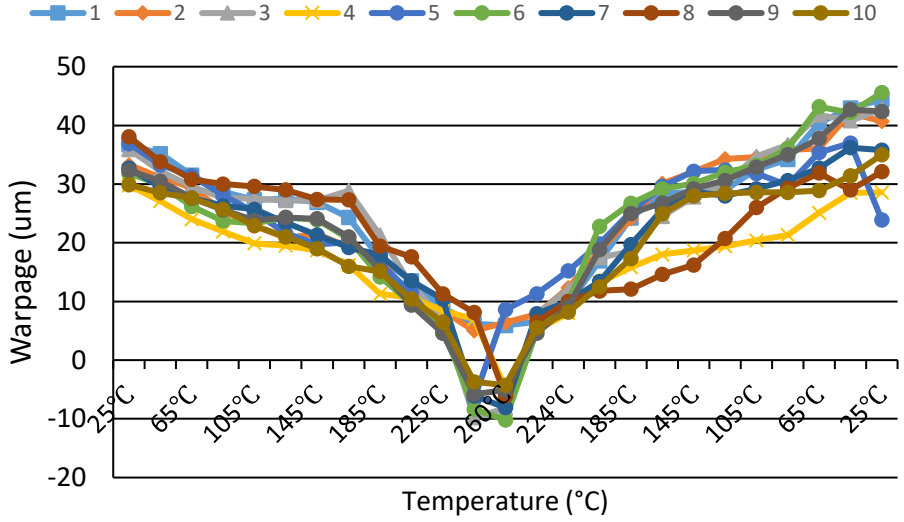
Shadow Moiré (4D)

Dry condition samples - meets Apple spec for all temperature range specified

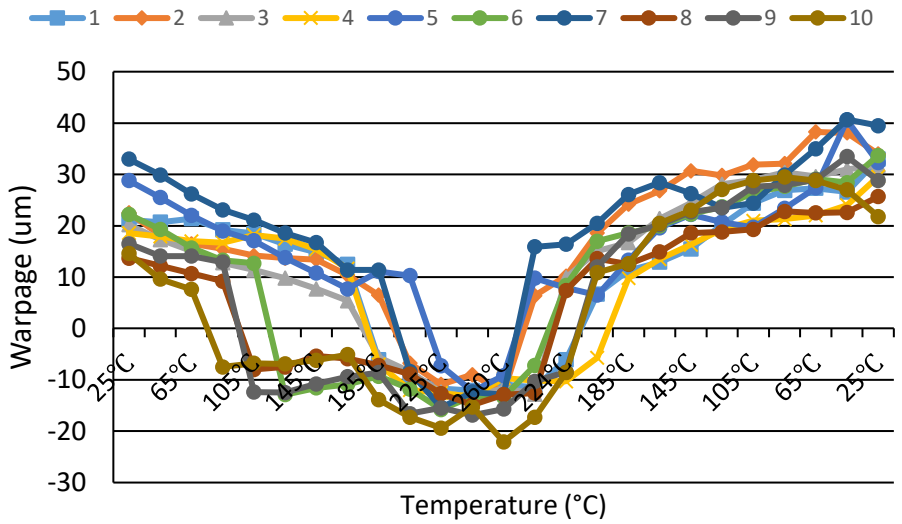
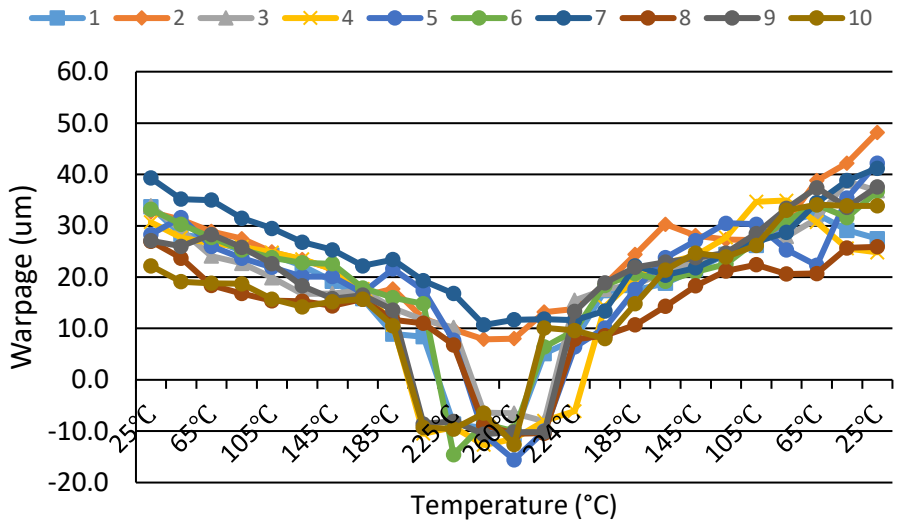
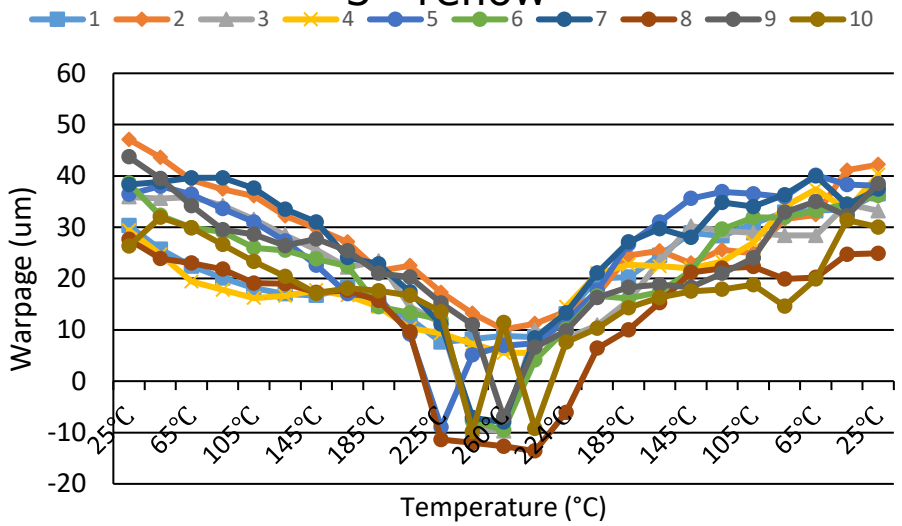
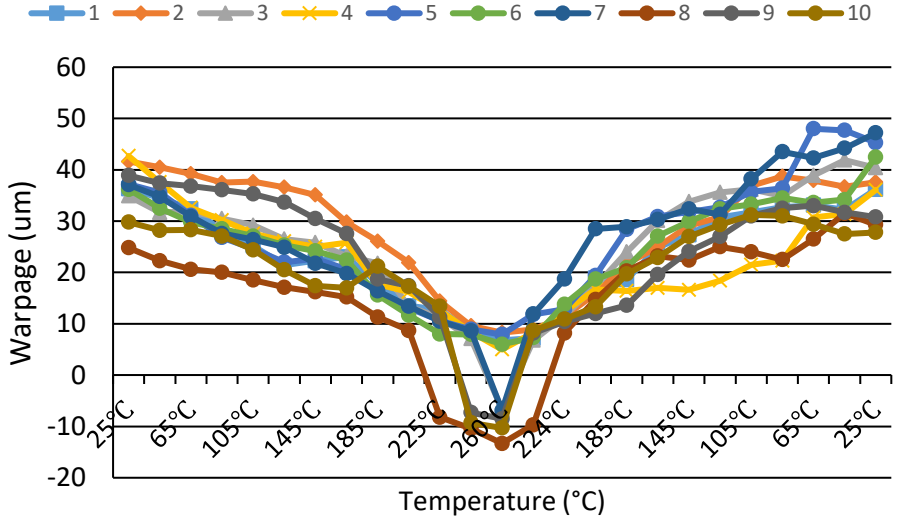
Shadow Moiré (4D)

Wet condition samples - meets Apple spec for all temperature range specified

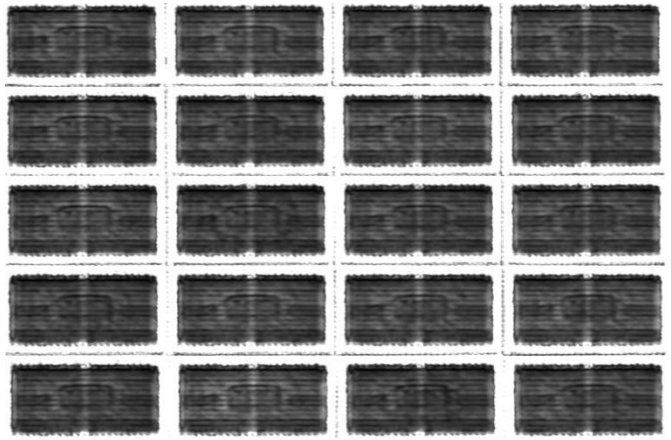
Contact Resistance and Delam check (4D)

- Data taken from 60 units from 3 PQ lots (20 units/lot)
- CSAM image post MSL3A shows no failures

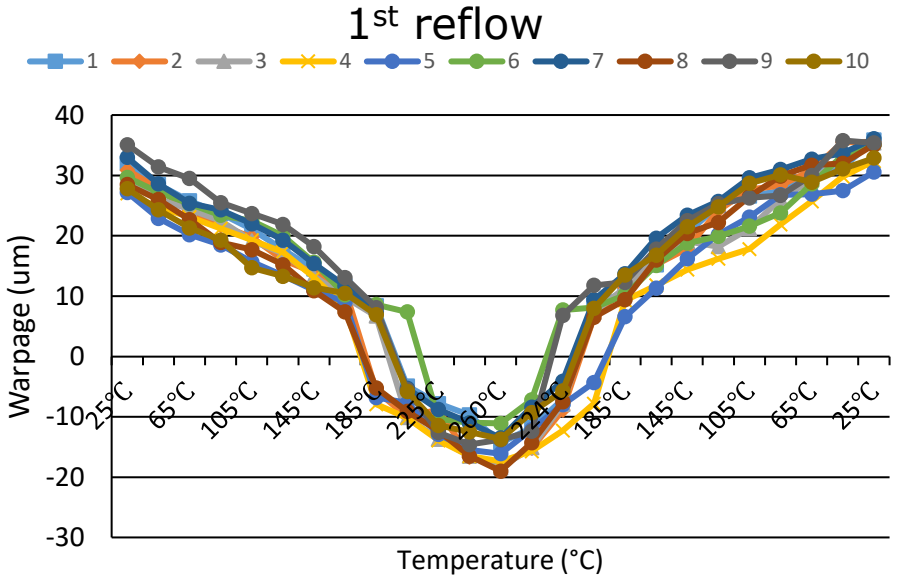
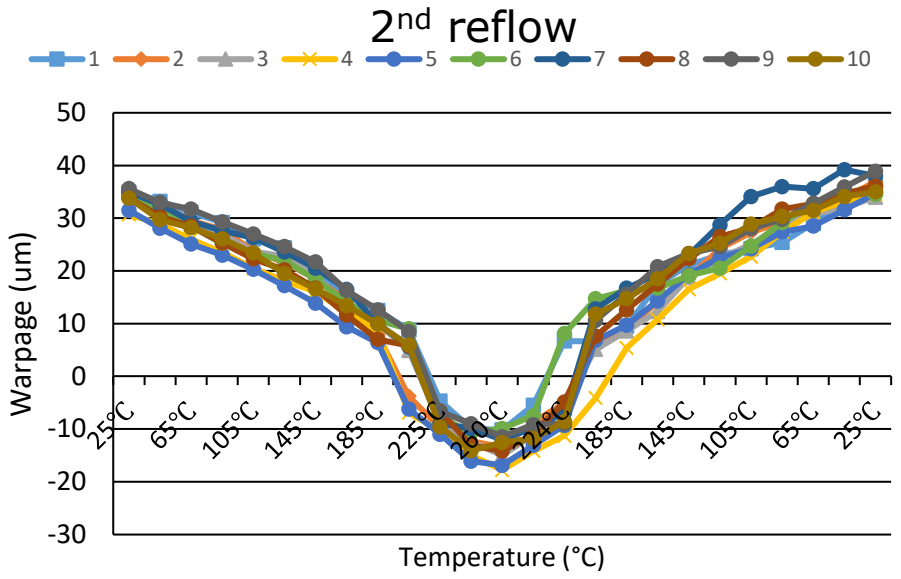
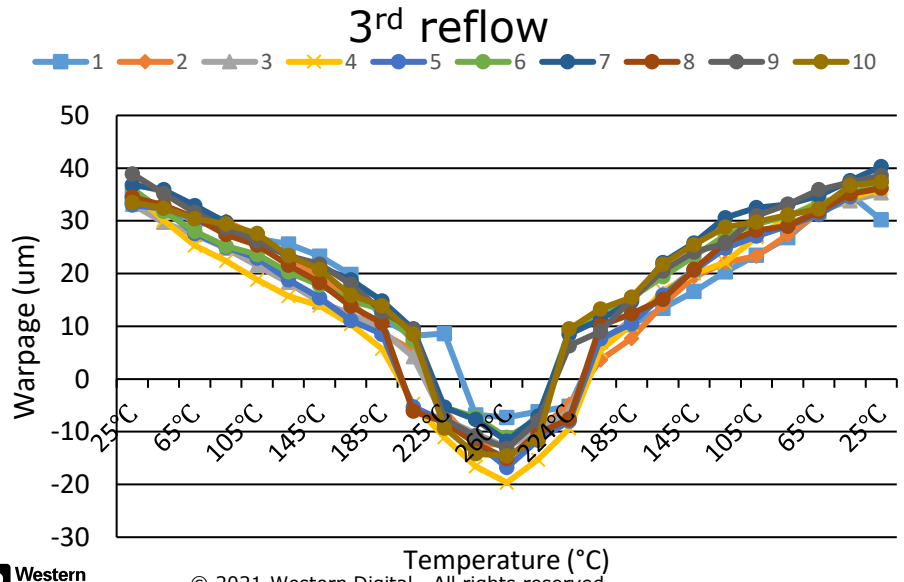
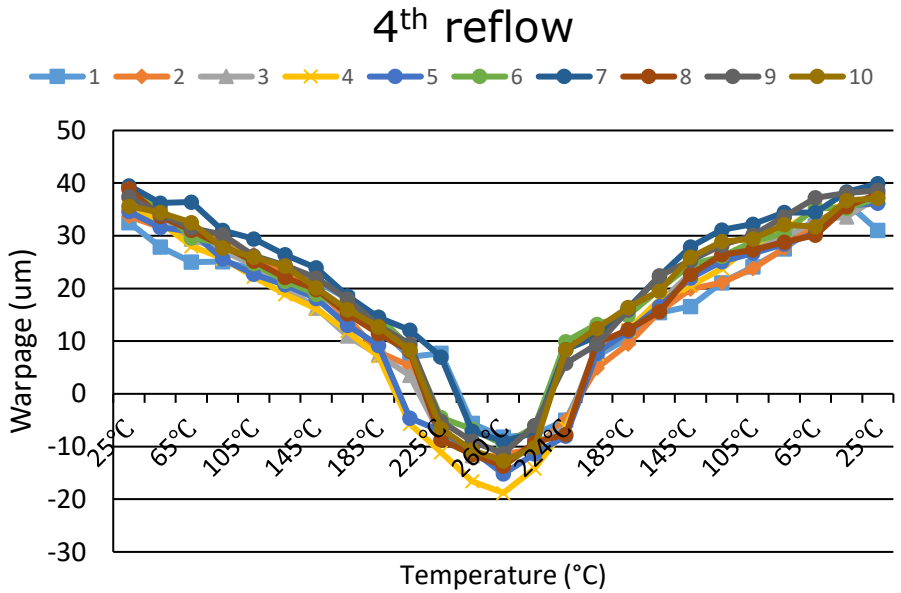
Shadow Moiré (8D)

Dry condition samples - meets Apple spec for all temperature range specified

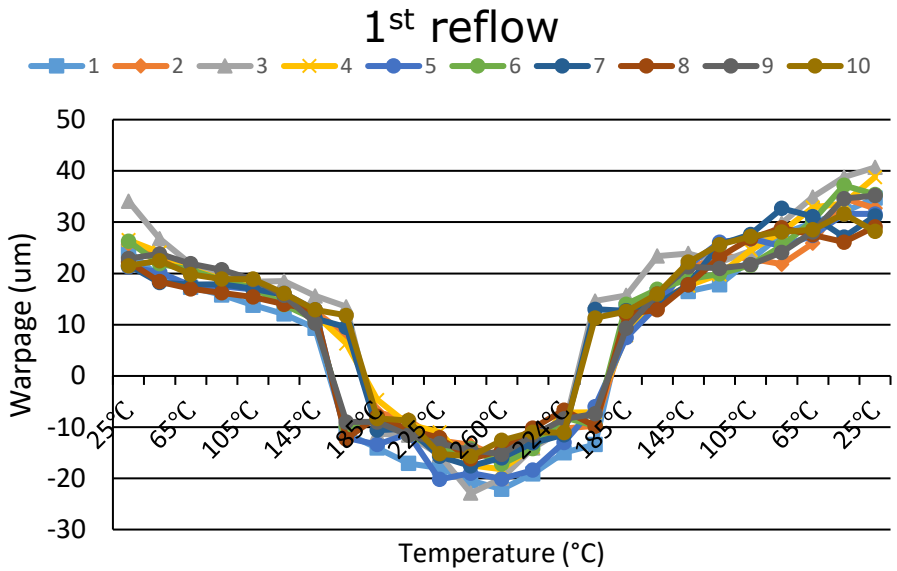
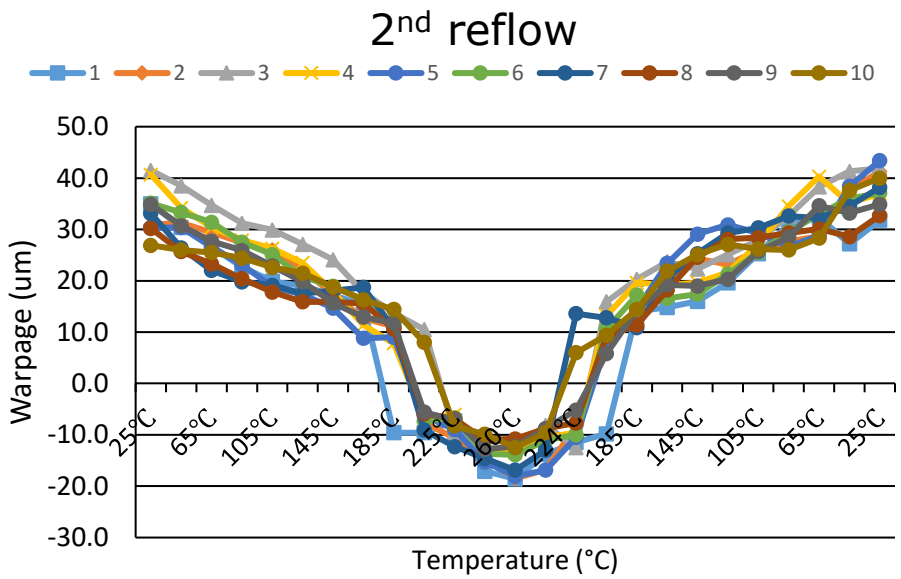
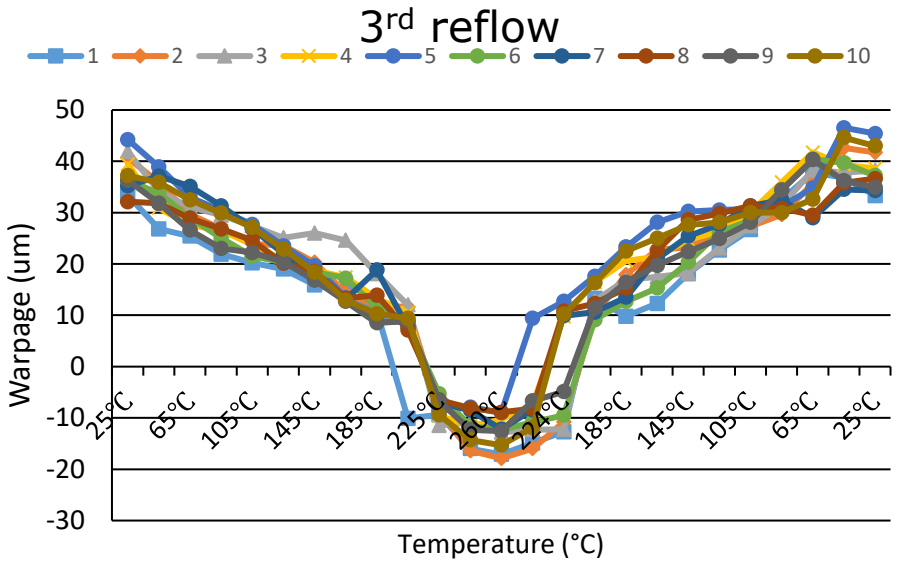
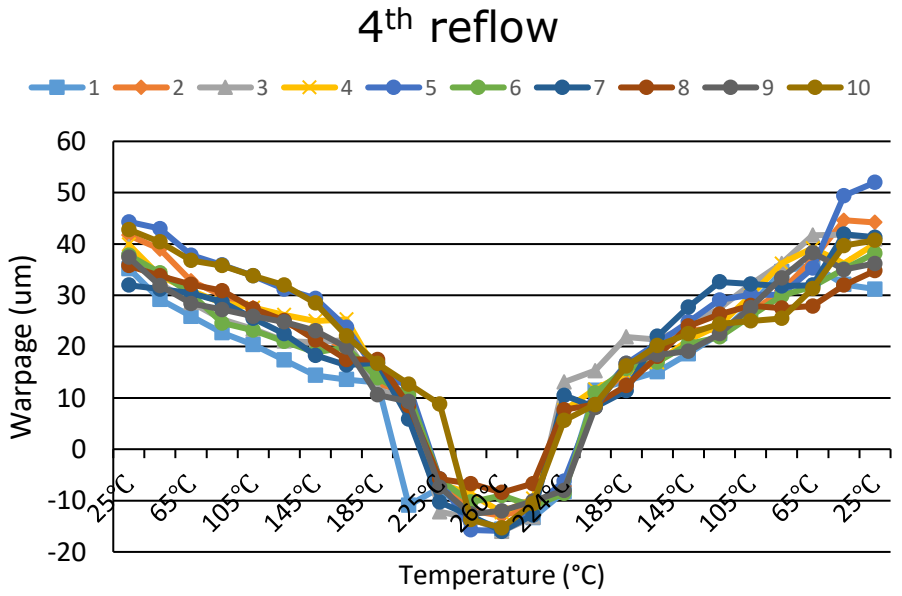
Shadow Moiré (8D)

Wet condition samples - meets Apple spec for all temperature range specified

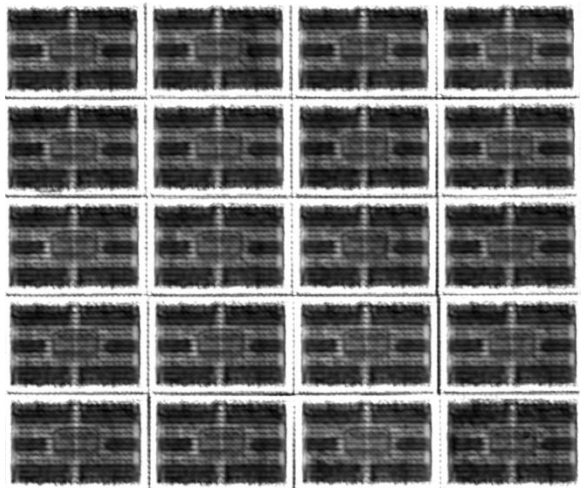
Contact Resistance and Delam check (8D)

- Data taken from 60 units from 3 PQ lots. (20 units/lot)
- CSAM image post MSL3A shows no failures.
